REPORT (FINAL)

# Cornwall Beach & Dune Management Plans – Par Sands

Cornwall Council

October 2016

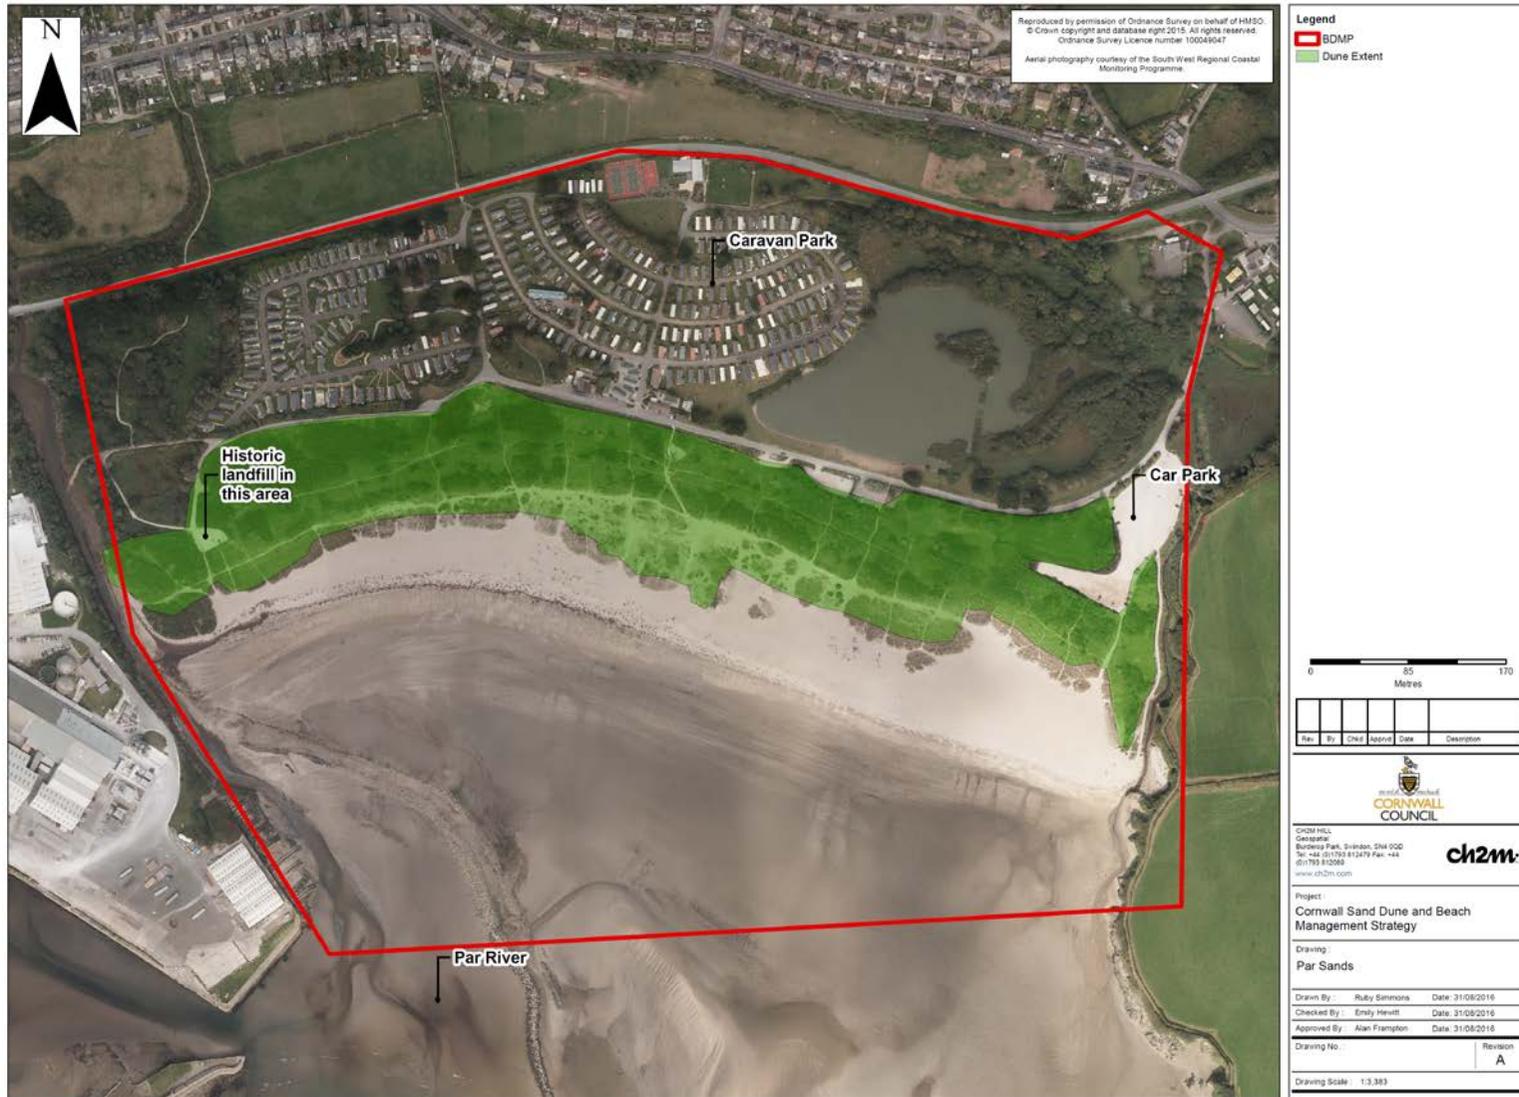
Figure 2.1 Map showing the Par Sands BDMP location and extent (red outline).

Par Sands is located on the south coast of Cornwall, approximately 4km to the east of St Austell. The beach is set-back within St Austell Bay, enclosed by the docks and china clay works in the west and the steep cliffs of Kilmarth in the east (refer to Figure 2.1).

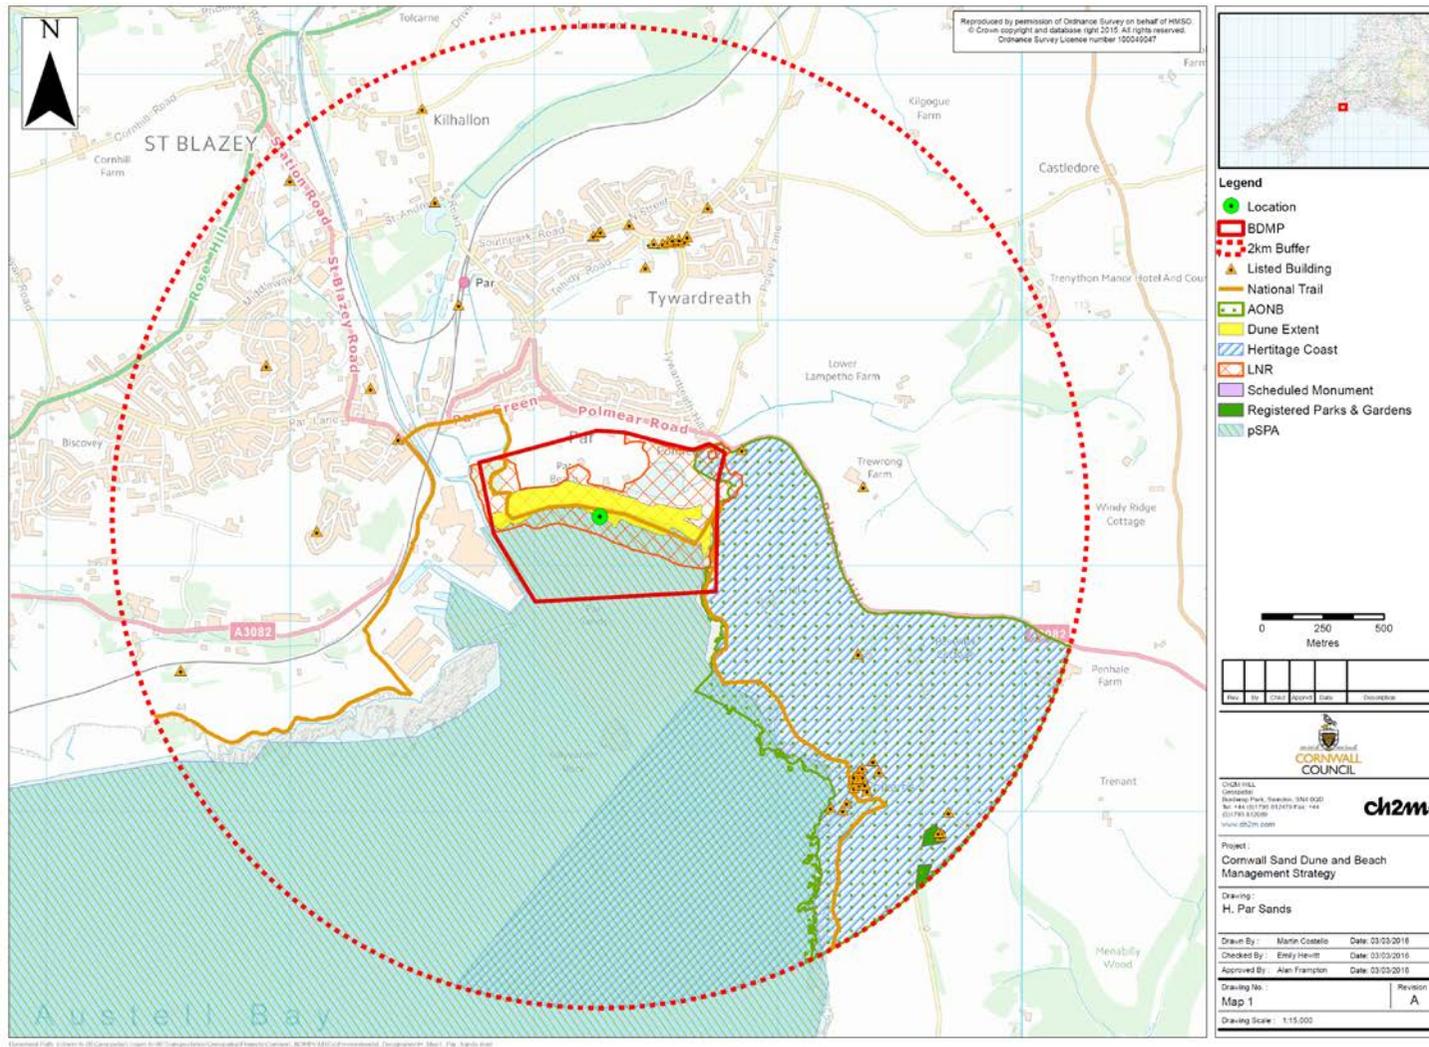
Figure 2.2 Environmental designation features in the vicinity of the Par Sands BDMP area.

These features are shown on Figure 2.2 and discussed in further detail below.

The following landscape designations run from the eastern edge of Par Beach (see Figure 2.2 above):

A number of historic sites are located within the area and include a registered Historic Park and Garden (Menabilly), a Scheduled Monument (Wayside Cross) and listed buildings (see Figure 2.2 above).

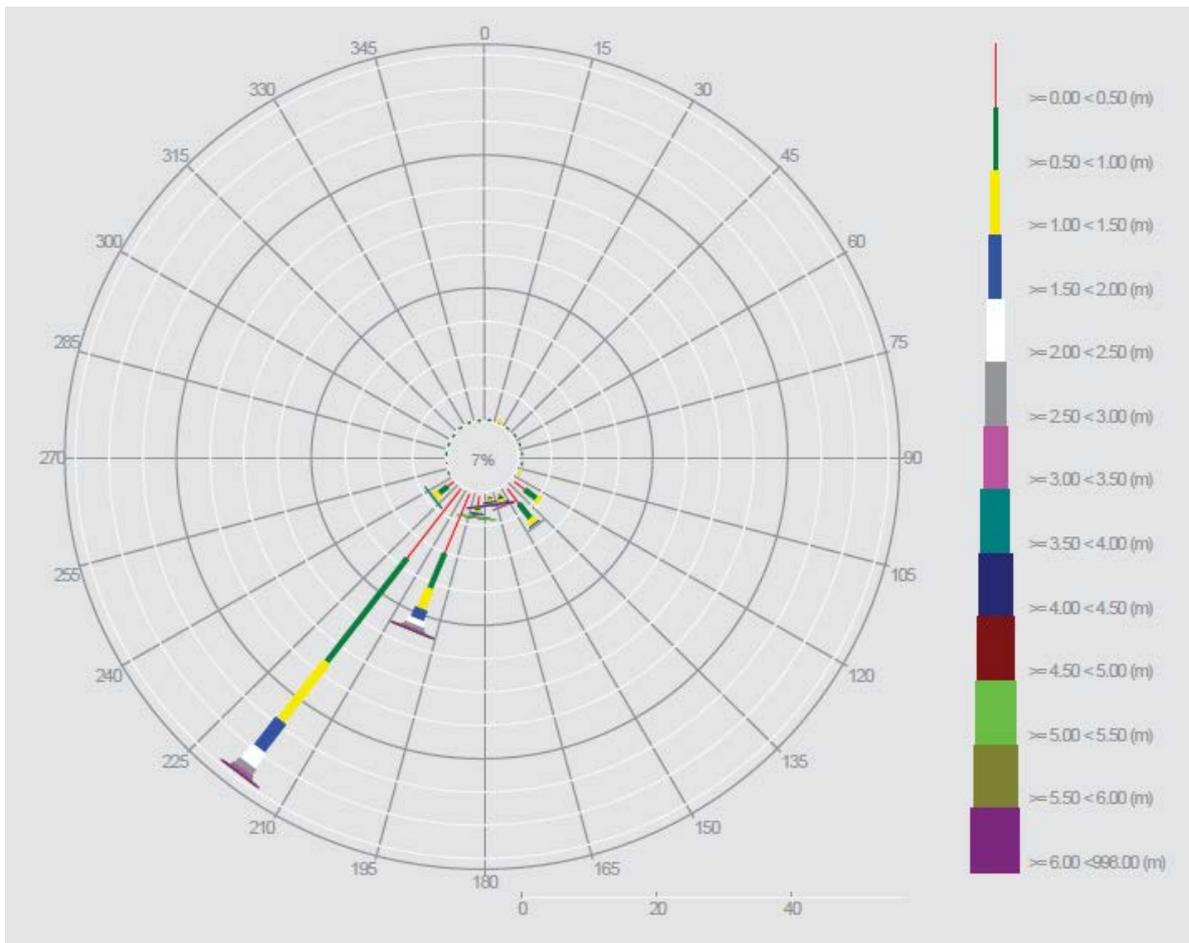
Figure 3.1 Offshore wave height recorded by the Looe Bay Directional Waverider Buoy between 22nd June 2009 and 30<sup>th</sup> June 2014 (PCO, 2014a).

The Looe Bay Directional Waverider Buoy, operated as part of the South West Regional Coastal Monitoring Programme (SWRCMP), is the nearest wave buoy to Par Sands, and has been reviewed for this study. The wave buoy is located approximately 15 miles east from Par Sands, and provides a record of wave height for a seven year period between 18<sup>th</sup> December 2006 and 30<sup>th</sup> June 2014. A plot of wave height in Figure 3.1 shows that the predominant wave direction in this area is from the west. The data set also indicates significant wave heights frequently exceed 5m during the winter months and that wave periods of 15 seconds and higher (i.e. powerful well waves generated by storms offshore) are not uncommon (Royal Haskoning, 2011b).

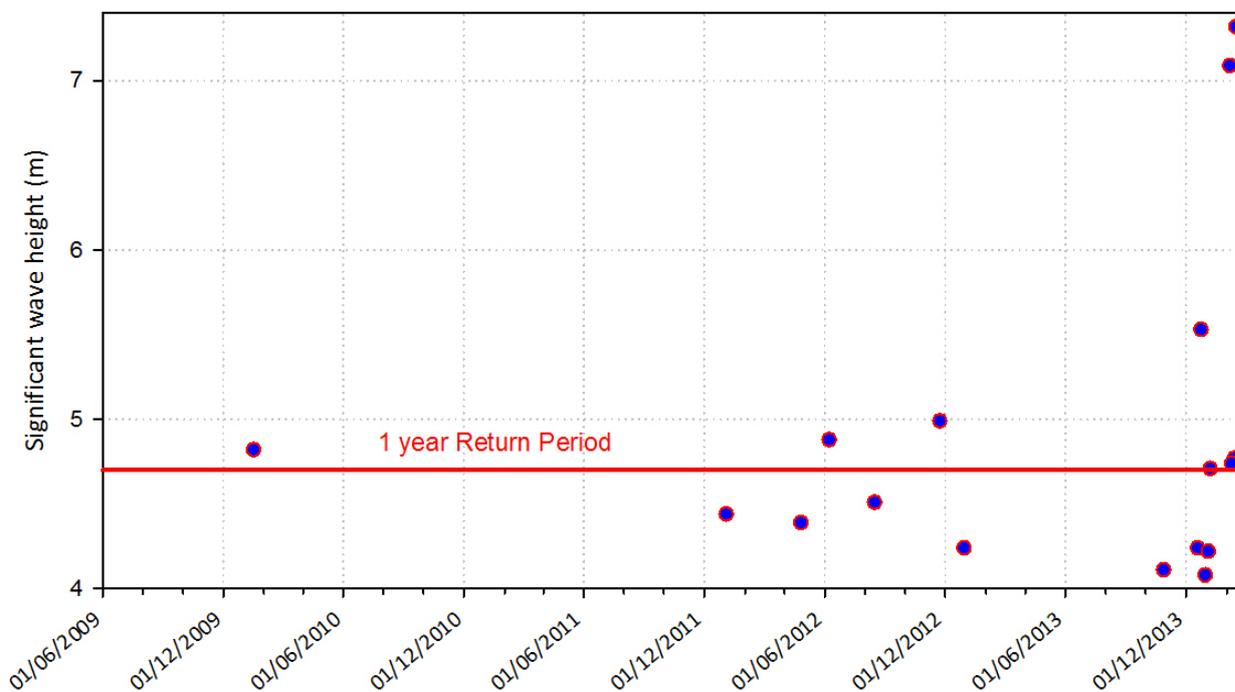
Figure 3.2 Storm calendar for Looe (source: PCO, 2014b).

For their reporting, PCO produce a storm calendar. The calendar includes a graph, where each dot represents a storm (i.e. where the  $H_s$  exceeds the storm threshold) and shows the  $H_s$  for that particular storm. PCO plot the significant wave height for the 1 year return period for that particular buoy on the graph (calculated in the same way as significant wave height for the 0.25 year return period) as a red line. Where storms plot above the red line they are considered to be more severe/extreme and are listed in a separate table. The storm calendar and table for the Looe Directional Waverider Buoy are presented in Figure 3.2 and Table 3.1 respectively.

The storm calendar shows that nine severe/extreme storms have exceeded the 1 year Return Period since 2009; six of those storms (67 %) occurred between October 2013 and February 2014. The impact of these storms on beach change is described in Section 3.3.

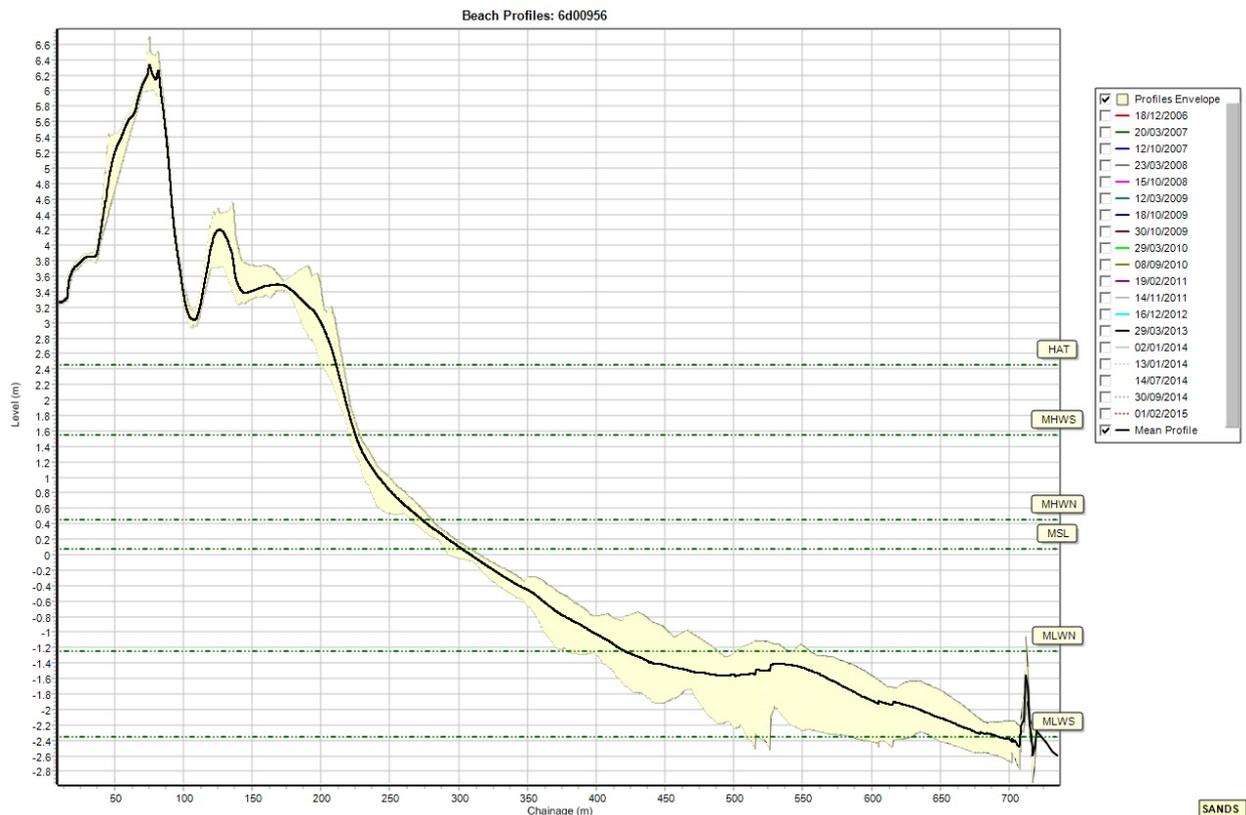
Figure 3.3 Tide levels in relation to typical beach-dune profile at Par Sands (based on SWRCMP monitoring data).

Tidal Condition	Tide Level (mOD)
Highest Astronomical Tide (HAT)	2.45
Mean High Water Spring (MHWS)	1.55
Mean High Water Neap (MHWN)	0.45
Mean Sea Level (MSL)	0.08
Mean Low Water Neap (MLWN)	-1.25
Mean Low Water Spring (MLWS)	-2.35
Lowest Astronomical Tide (LAT)	Data not available

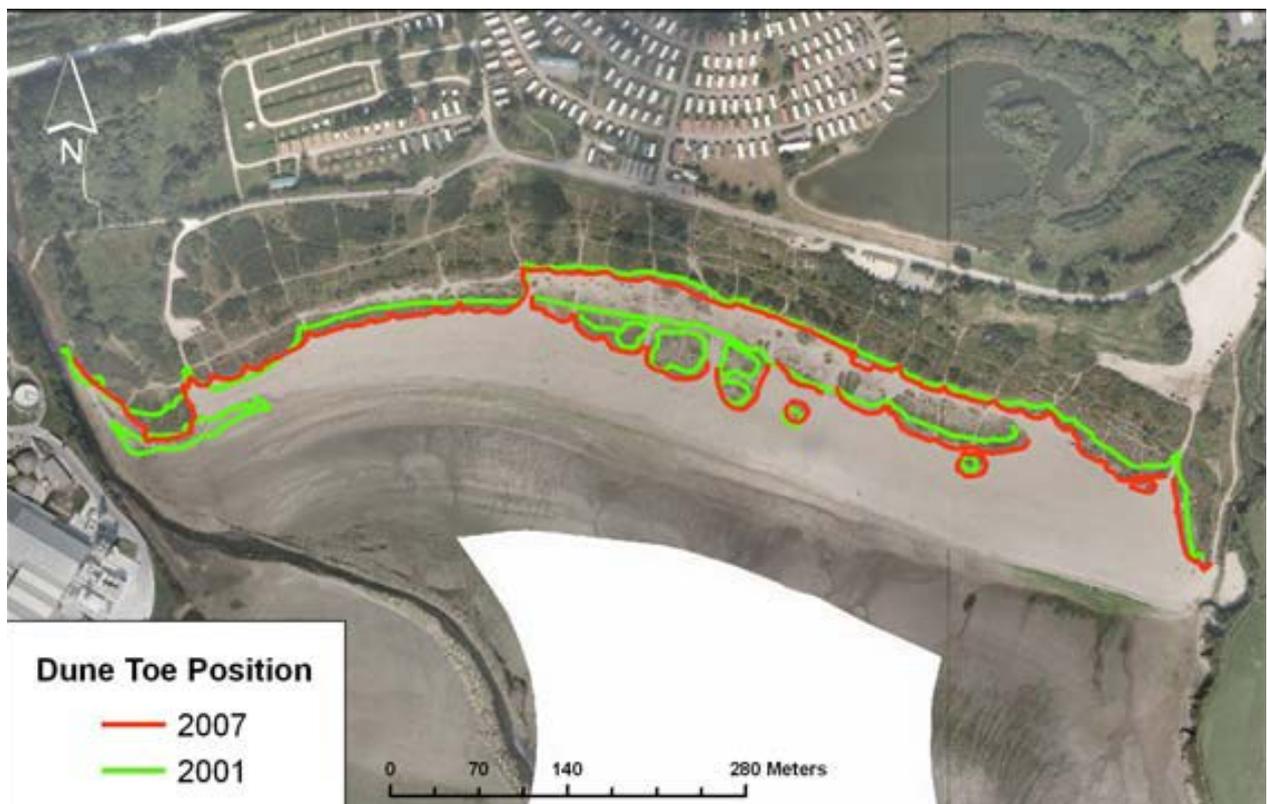
Figure 3.4 Dune toe position at Par Sands in 2001 and 2007 (source: Halcrow, 2009c).

Using aerial photographs, the dune toe was digitised and compared (refer to Figure 3.4). The analysis shows that the between 2001 and 2007:

- Significant accretion along the majority of the frontage of the dunes at Par Sands. In general, the seaward face of the fully mature dune system has accreted seaward between 5 and 13m over the 5 year period. This represents an average rate of accretion of between 1 and 2.5m per year.
- The exception to this is at the western extremity of the beach (nearest the river), where a stretch of dunes roughly 60m wide eroded landwards approximately 5m, and where a section of foredune roughly 100m wide by 10m deep was completely lost.
- Over this period, there was notable build-up of the foredunes in the middle of the beach over the past 5 years, with the original embryo dunes increasing in width and growing slightly seaward. The density of vegetation cover appeared to have increased over time as well.

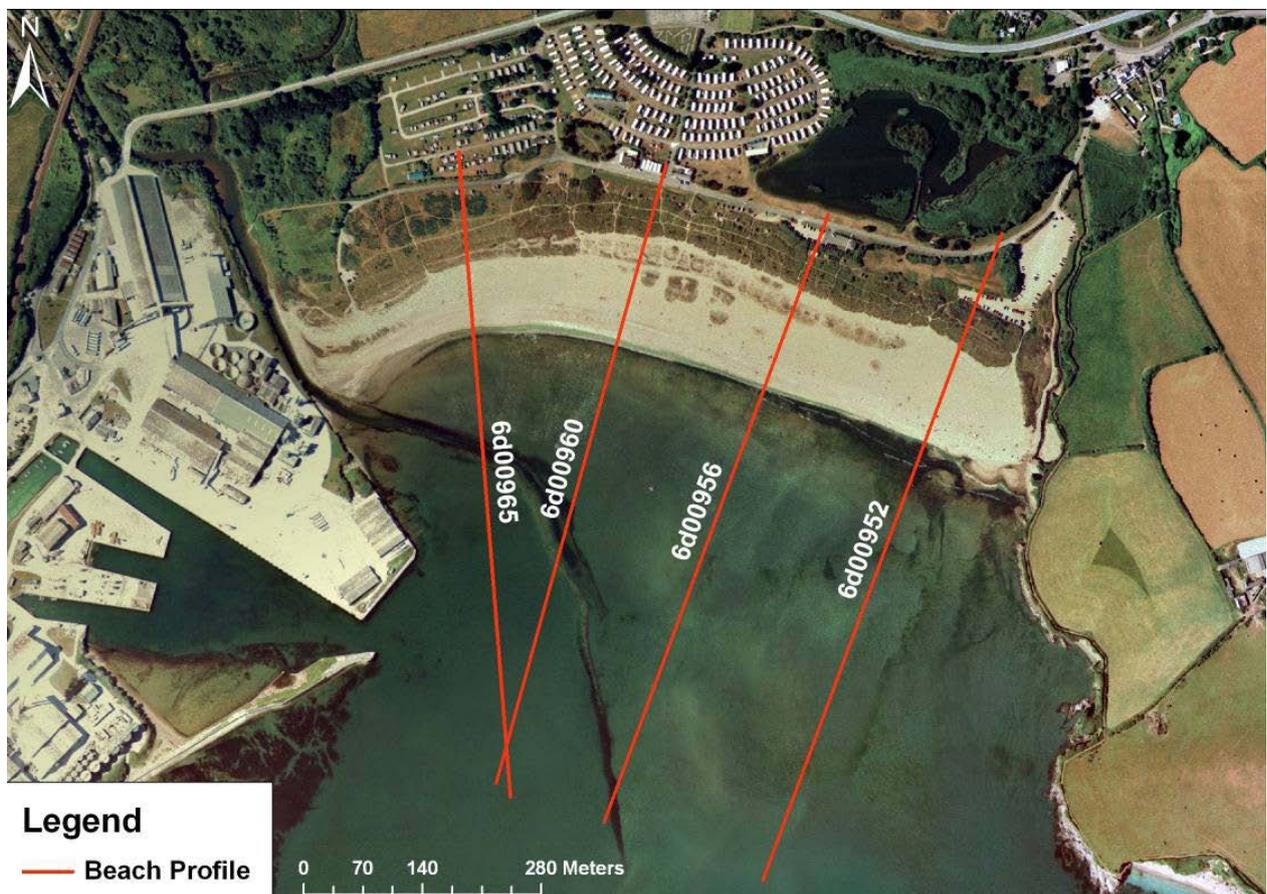
Figure 3.5 Diagram showing position of SWRCMP beach profiles at Par Sands.

- Dunes: The four profiles at Par Sands generally show no discernible trends for the dune area. All changes over this period equate to less than 1% of the material present above the master profile. The maximum variability on any profile was 10m<sup>2</sup>, but this equates to a small volume over the 100m of dunes surveyed. The exception to this along the two profiles (6d00956 and 6d00960) in the centre of the site, which show a slight increase in the sand levels on top of a foredune in front of the main dune system. The increase in crest height of the foredune feature was in the order of 15 to 50 cm between 2008 and 2006, indicating that this may be a growing feature.

- Beach: Only one of the four profiles showed a loss of beach material over the analysis period. The western-most profile lost 1% of its CSA over that time. A possible explanation for this is the loss of the foredune in this area. The other three profiles remained stable or accreted slightly.

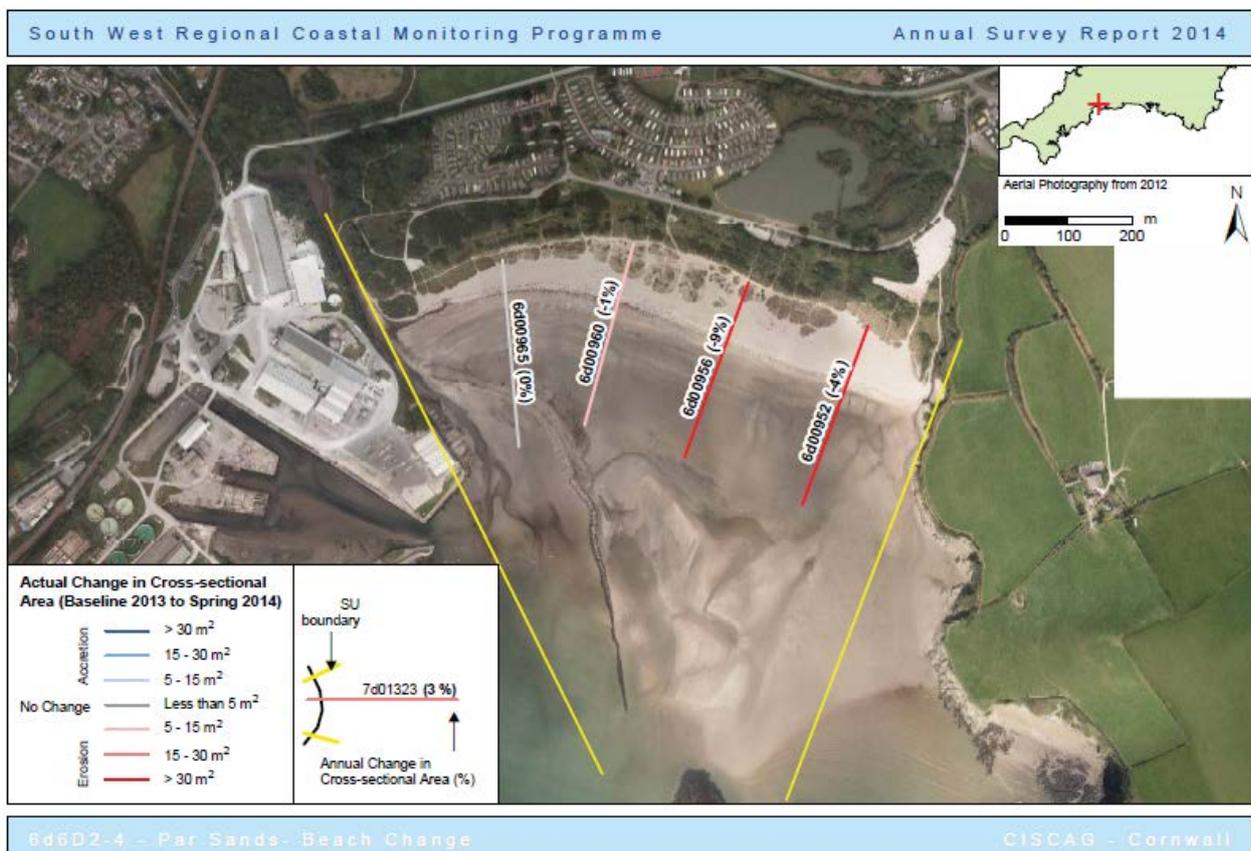
Figure 3.6 Beach profile change at Par Sands Spring 2013 to Spring 2014 (source: PCO, 2014a).

- The long-term volume change between the baseline survey in 2007 and Summer 2013 was 16,400m<sup>3</sup>. The net change over the 2013/2014 winter period (from March 2013 to January 2014) was -27,400m<sup>3</sup>, but the net change from Winter 2013/14 to Summer 2014 was 20,522m<sup>3</sup>. The percentage of beach volume recovered by Summer 2014 was therefore +75% (refer to Figure 3.9).
- The topographic difference model plot for Par Sands (refer to Figure 3.10) shows the beach elevation change between the 21<sup>st</sup> March 2012 and 1<sup>st</sup> April 2014. The plots shows that the dunes have accreted vertically over this time and a reduction in beach level along the MHW line (particularly at the western end around the site of fill, corresponding to loss following the 2013/2014 storms, and the eastern end of the beach).

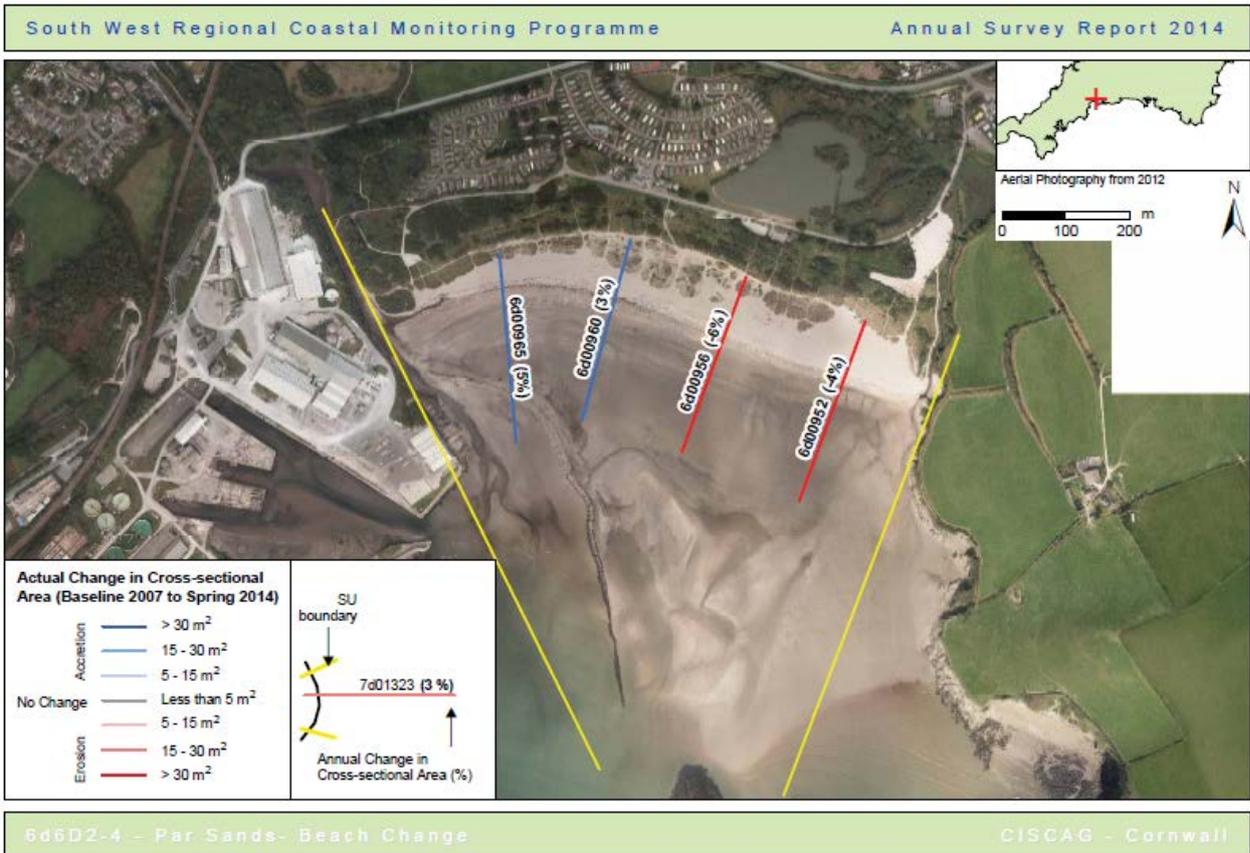
Figure 3.7 Beach profile change at Par Sands baseline 2007 to Spring 2014 (source: PCO, 2014a).

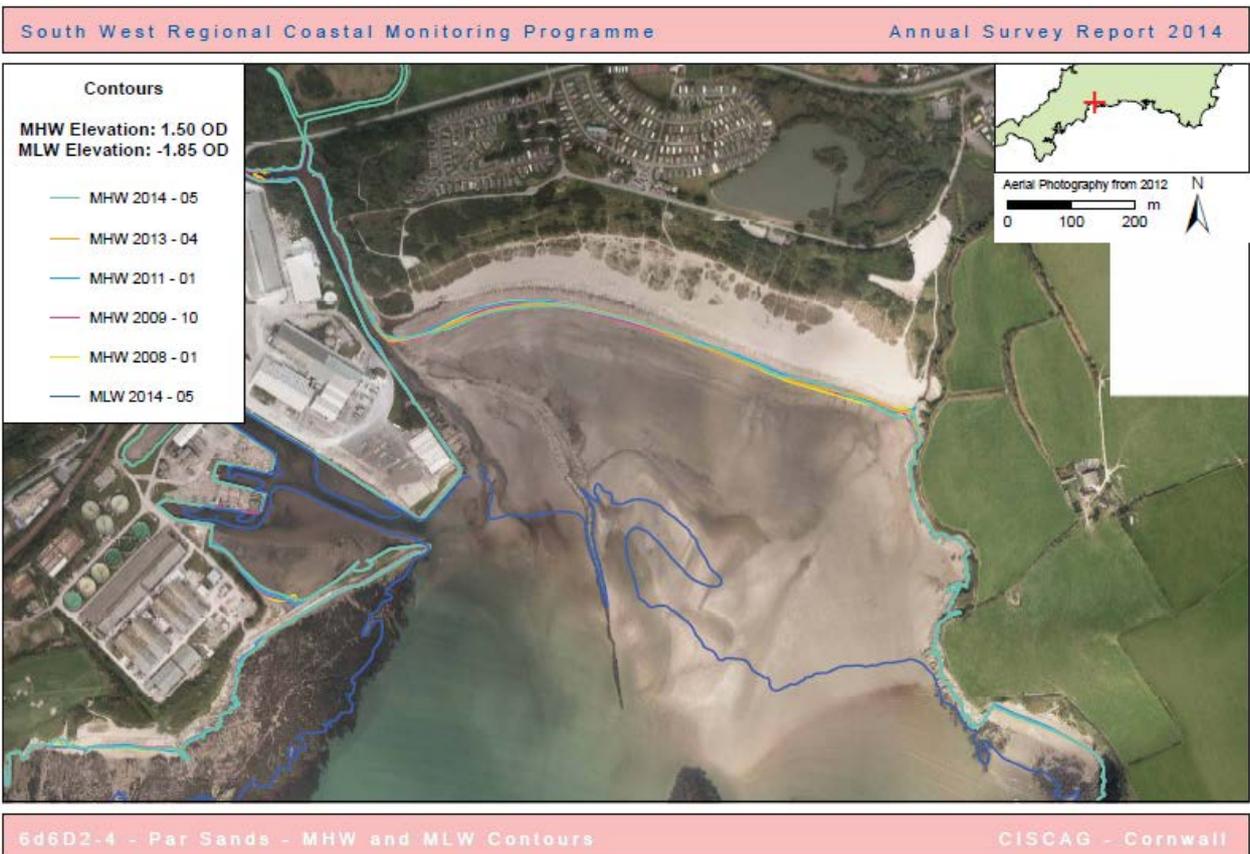
Figure 3.8 MHW contour change at Par Sands (source: PCO, 2014a).

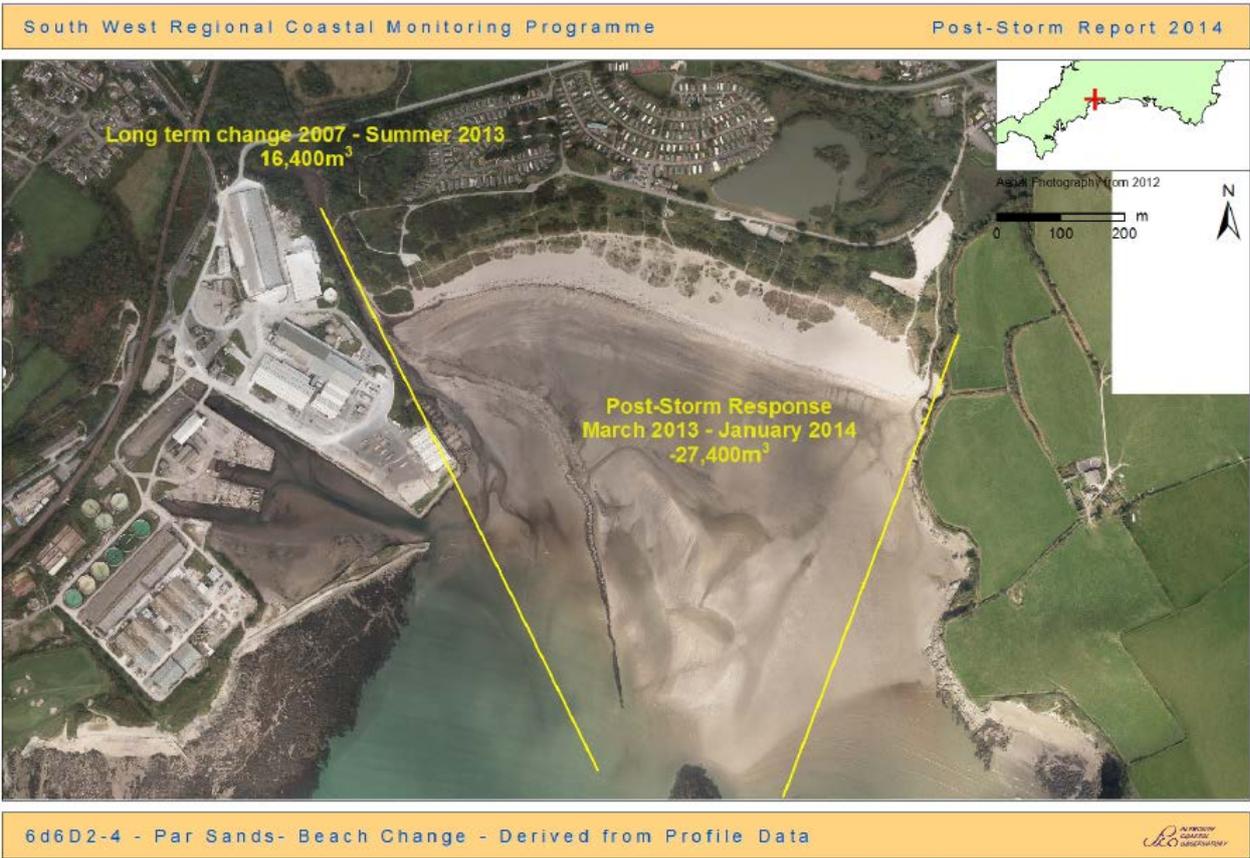
Figure 3.9 Volume change at Par Sands (PCO, 2014b).

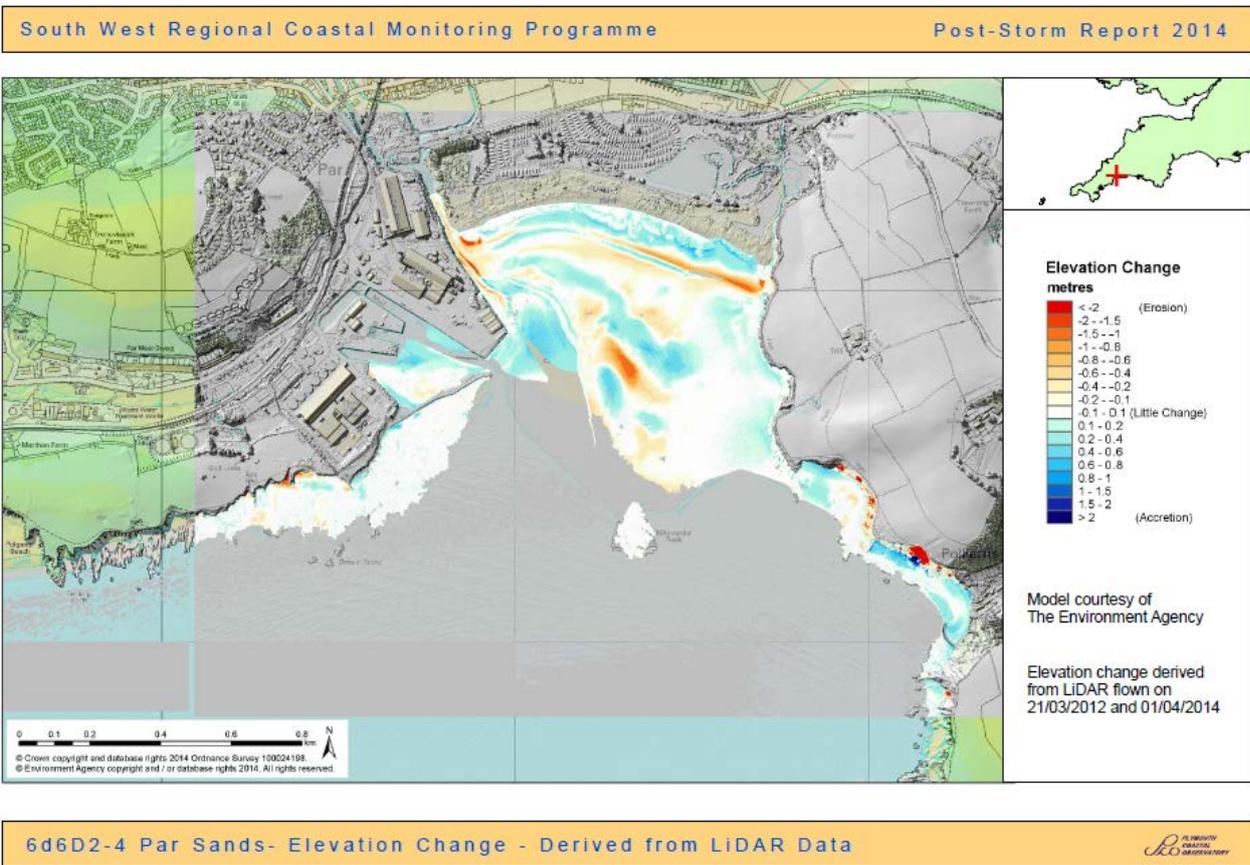
Figure 3.10 Post storm elevation change at Par Sands (source: PCO, 2014c).

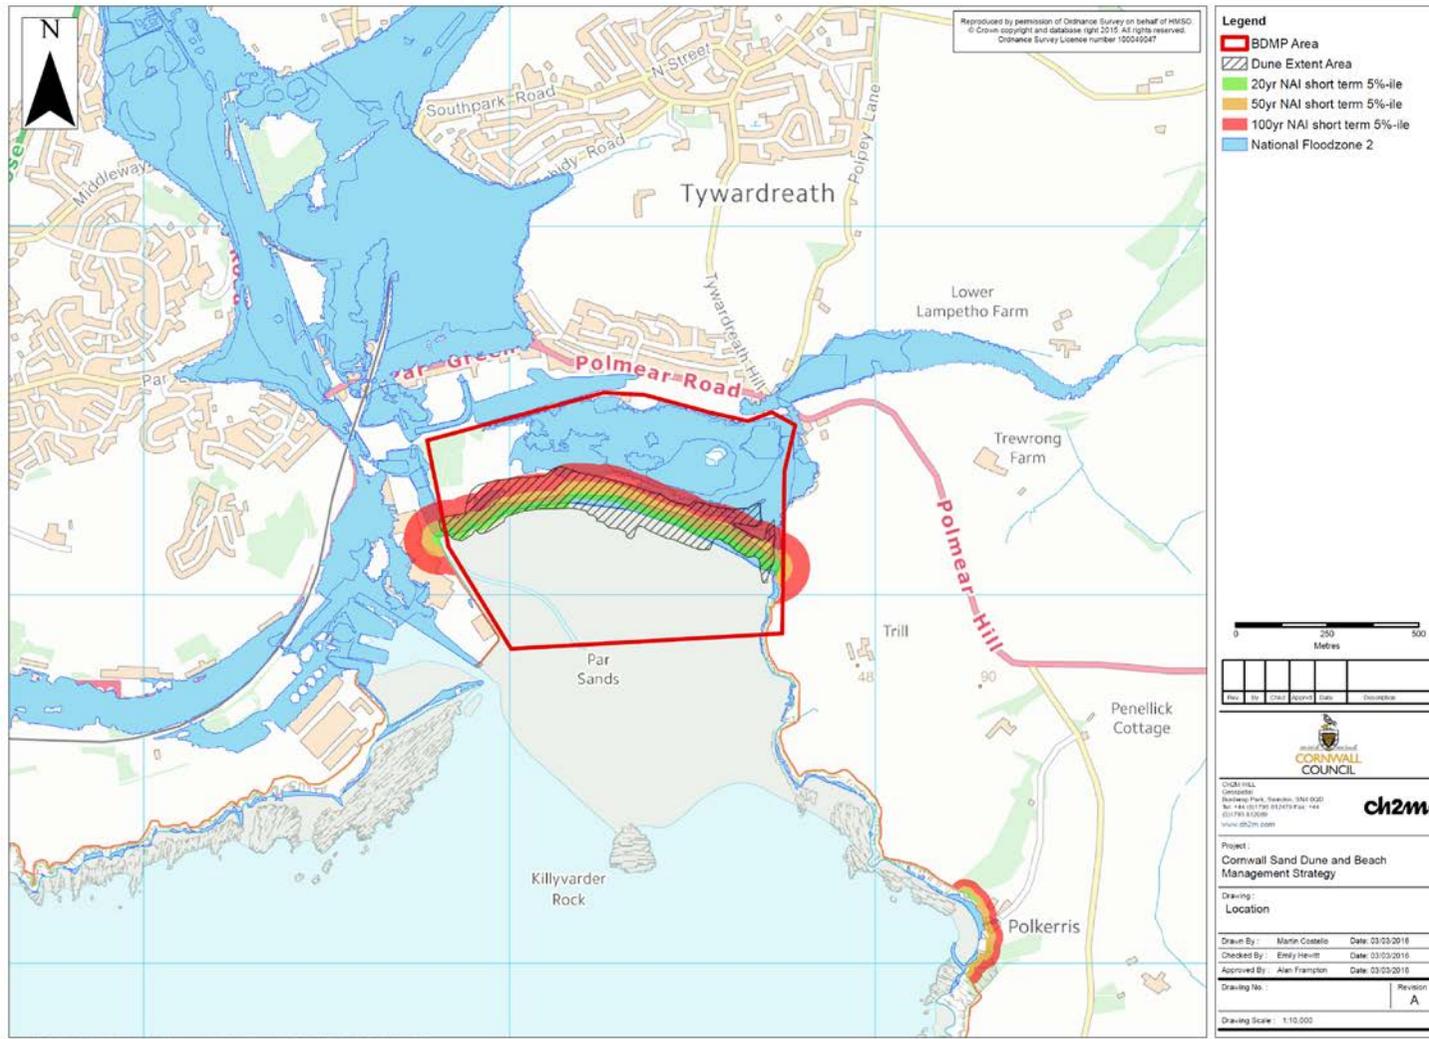
Figure 3.11 Flood and erosion risk projections for Par Sands.

The key issue at Par Sands is that the dunes provide a flood defence function to the low-lying land behind. The dunes appear to be stable and in places accreting, so intervention required at present is probably limited. However, as sea levels rise and without new influx of sediment, this accreting trend will like stop and reverse to become one of erosion. This will in turn lead to erosion and narrowing of the dunes, particularly if the dune system is constrained from migrating landwards due natural or human factors. The size of the dunes in this area will therefore reduce, making the system more vulnerable to storm impacts and increased risk of erosion leading to breaching and so flooding. The extent of potential flooding and erosion is shown in Figure 3.11.

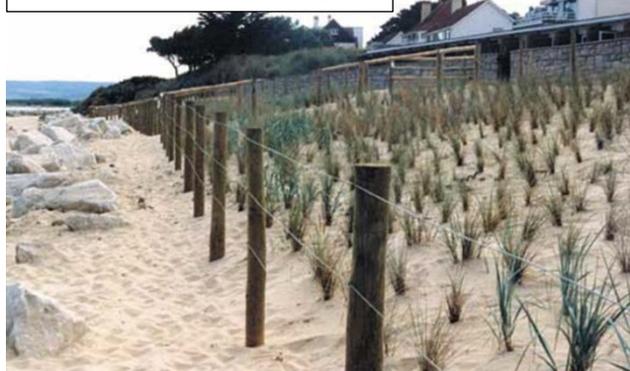
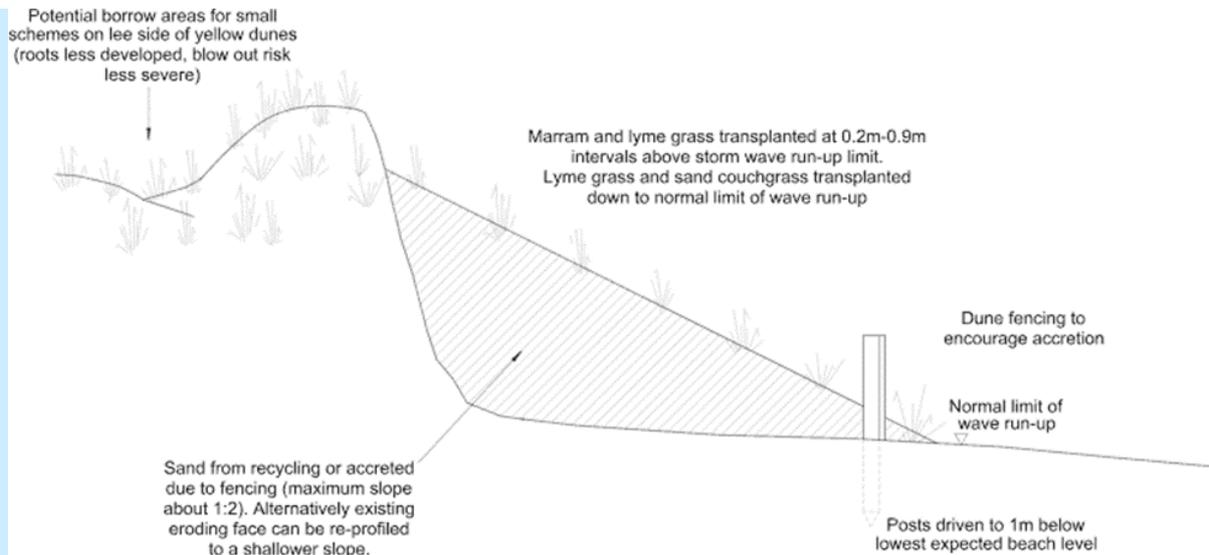
Example of dune planting

- Planting grasses from seed is not recommended in the very active foredune environment.
- Planting should be undertaken in the spring to maximise potential growth and minimise the risk of storm erosion.

- Dune planting schemes must be continuously managed to establish a vigorous growth and to repair natural or human damage.
- Re-profiling, thatching or fencing are normally required in association with planting to enhance dune recovery and to restrict public access or damage.

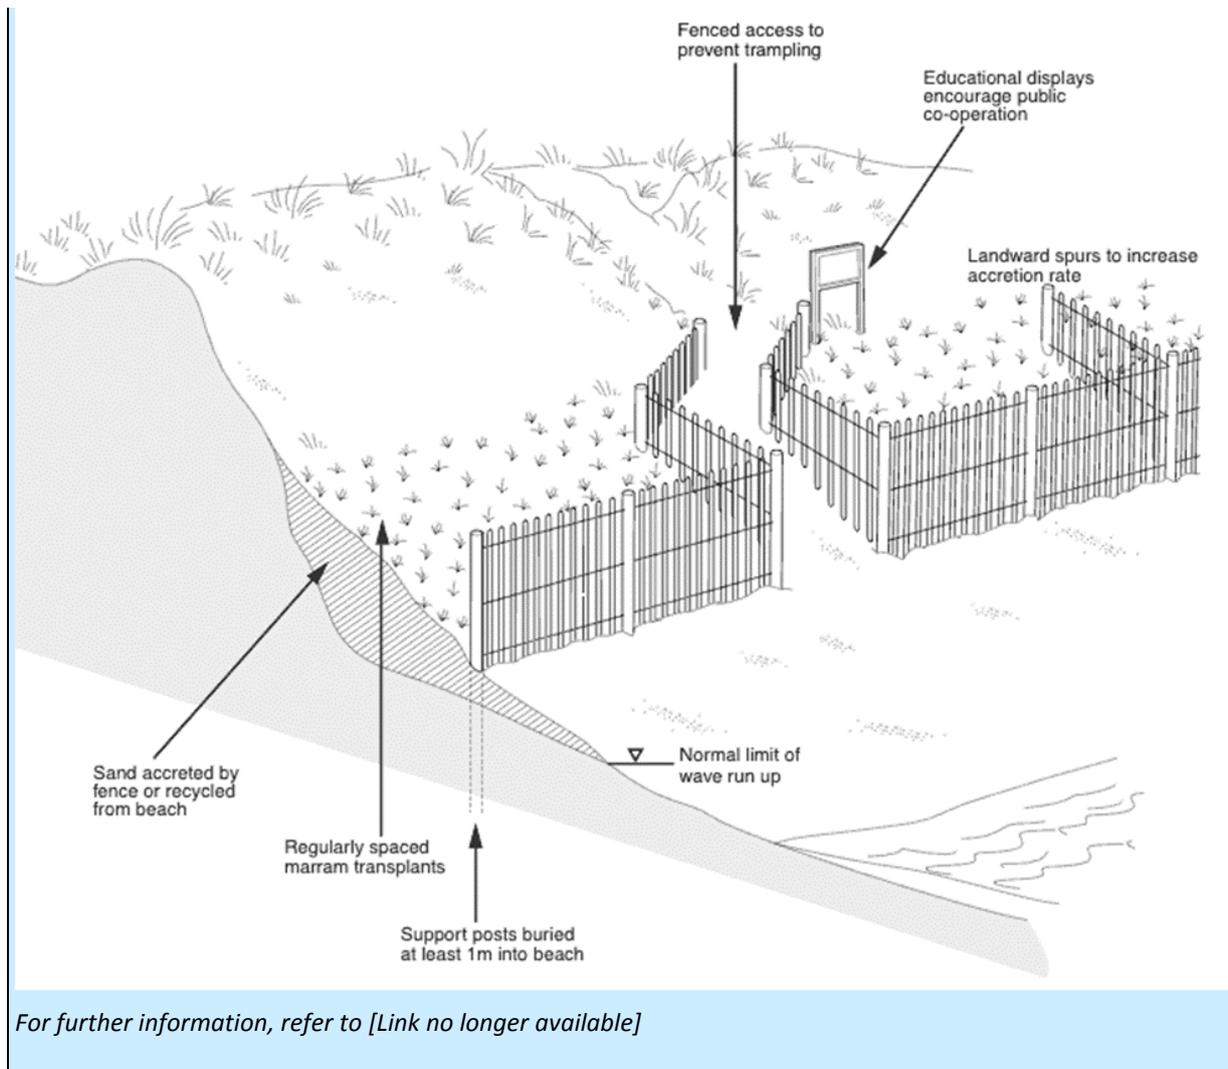
- The void to solid ratio for any fence material should be between 30% and 50% to achieve effective sand accumulation.
- Fencing can be undertaken at any time of year and should be complemented with dune grass planting after the fencing is in place.

- Access routes through the dunes should be defined by the fencing at regular intervals along the dune face.

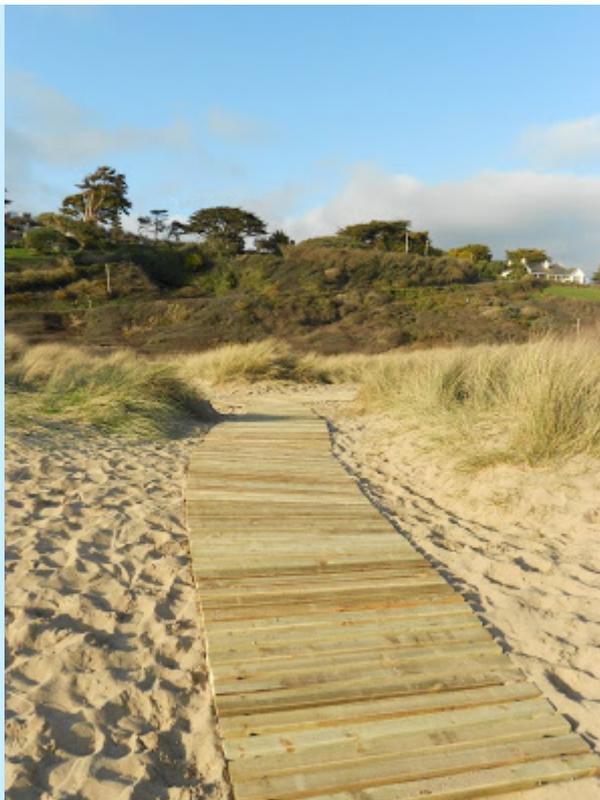
Example of a removable access structure (Source: <http://lizardandpenrose.blogspot.co.uk/2012/03/under-boardwalk.html>; link correct when accessed on 29<sup>th</sup> July 2016).

- For permanent walkways consider materials that will resist rot and other deterioration, such as wood and wood composites.
- For removable options non-wood materials such as bark chips or matting are low cost and have low impact on the environment.

- Elevated structures should be at least 2 feet above the surrounding dune to allow movement of sand or sediments, dune growth, and enough sunlight to penetrate under the structure for plant growth.

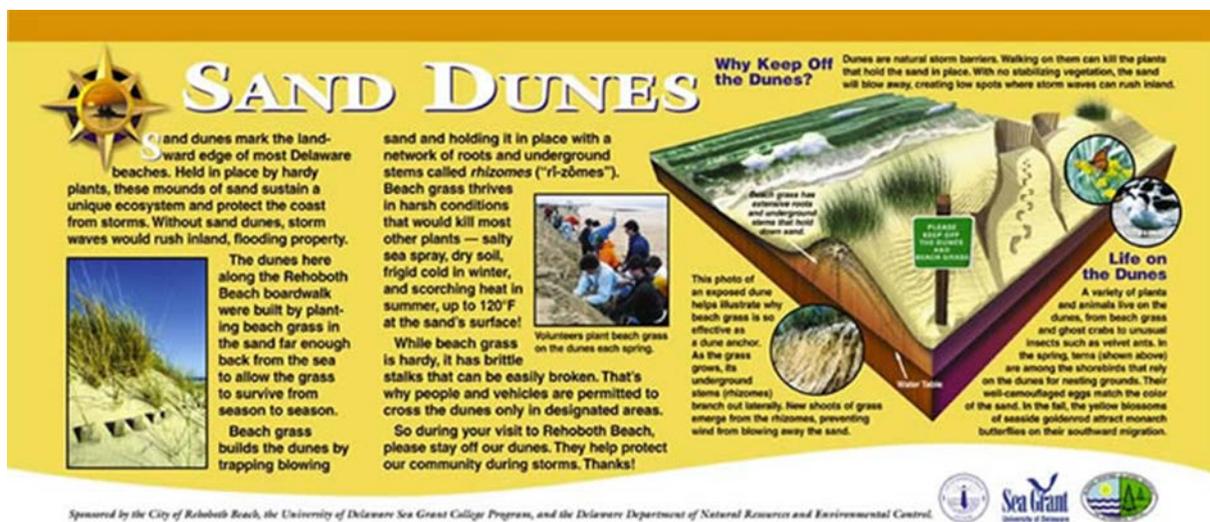
Figure 4.1 Sand dune educational signage example (from <https://www.deseagrant.org> link correct when accessed on 29<sup>th</sup> July 2016).

Figures 4.1 to 4.4 provide examples of different types of signage.

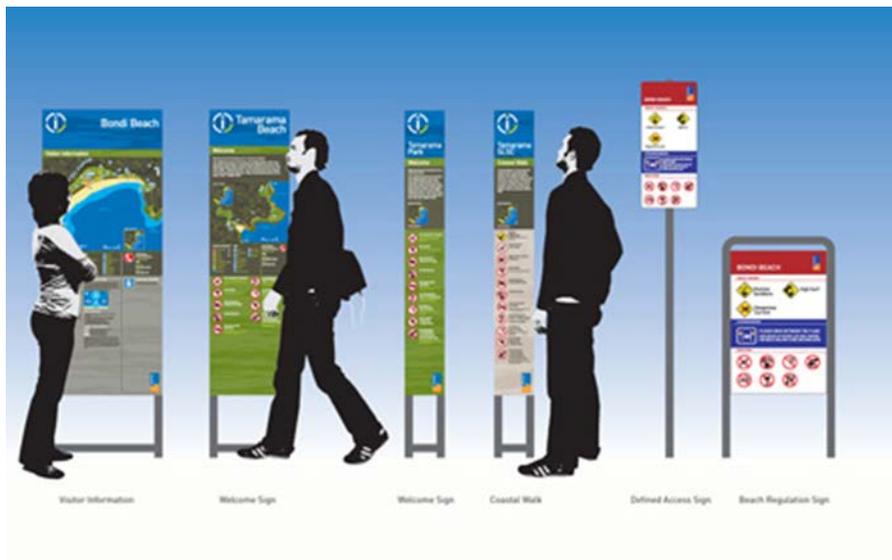
Figure 4.2 Beach signage examples (from <http://www.screenmakers.com.au/services/parks-and-places/bondi-to-bronte-coastal-walk>; link correct when accessed on 29<sup>th</sup> July 2016).

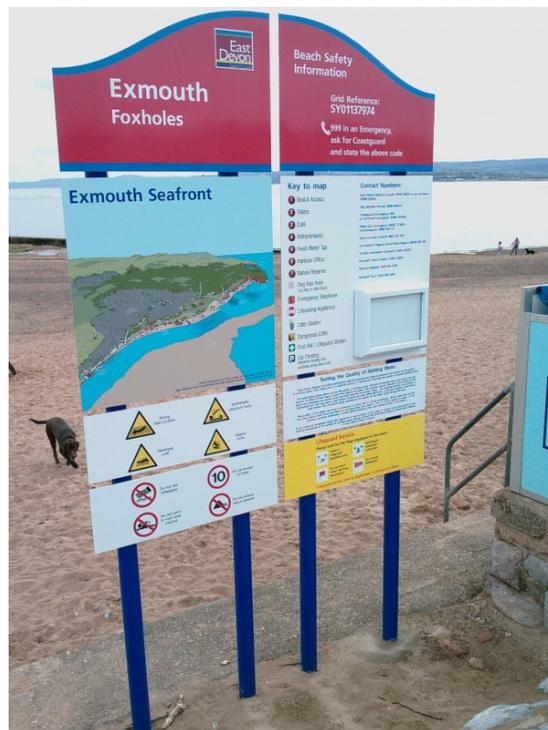
Figure 4.3 Post and panel beach signage example, Exmouth (from <http://www.signsexpress.co.uk> link correct when accessed on 29<sup>th</sup> July 2016).

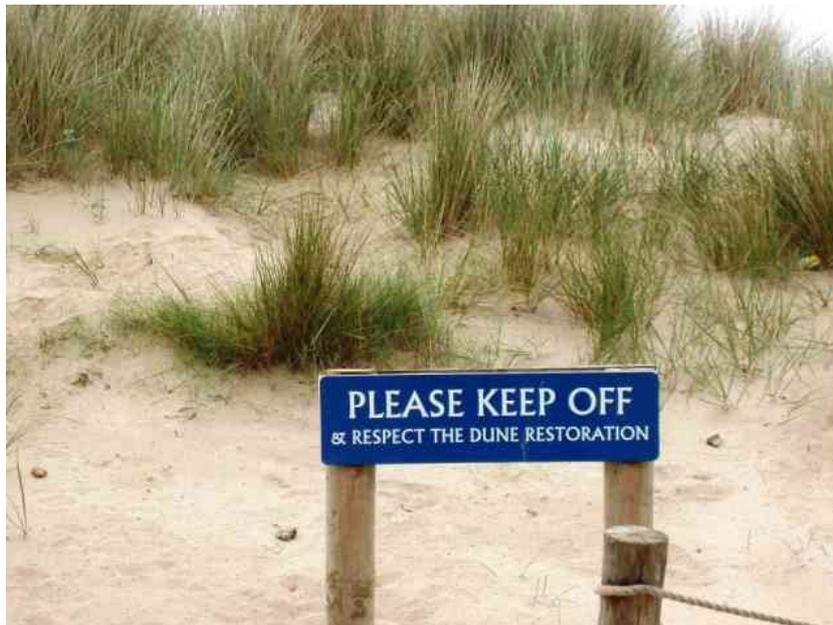
Figure 4.4 Dune signage example, Studland Bay (from <http://www.earthstudies.co.uk> link correct when accessed on 29<sup>th</sup> July 2016).
