REPORT (FINAL)

# Cornwall Beach & Dune Management Plans – Par Sands

Cornwall Council

October 2016

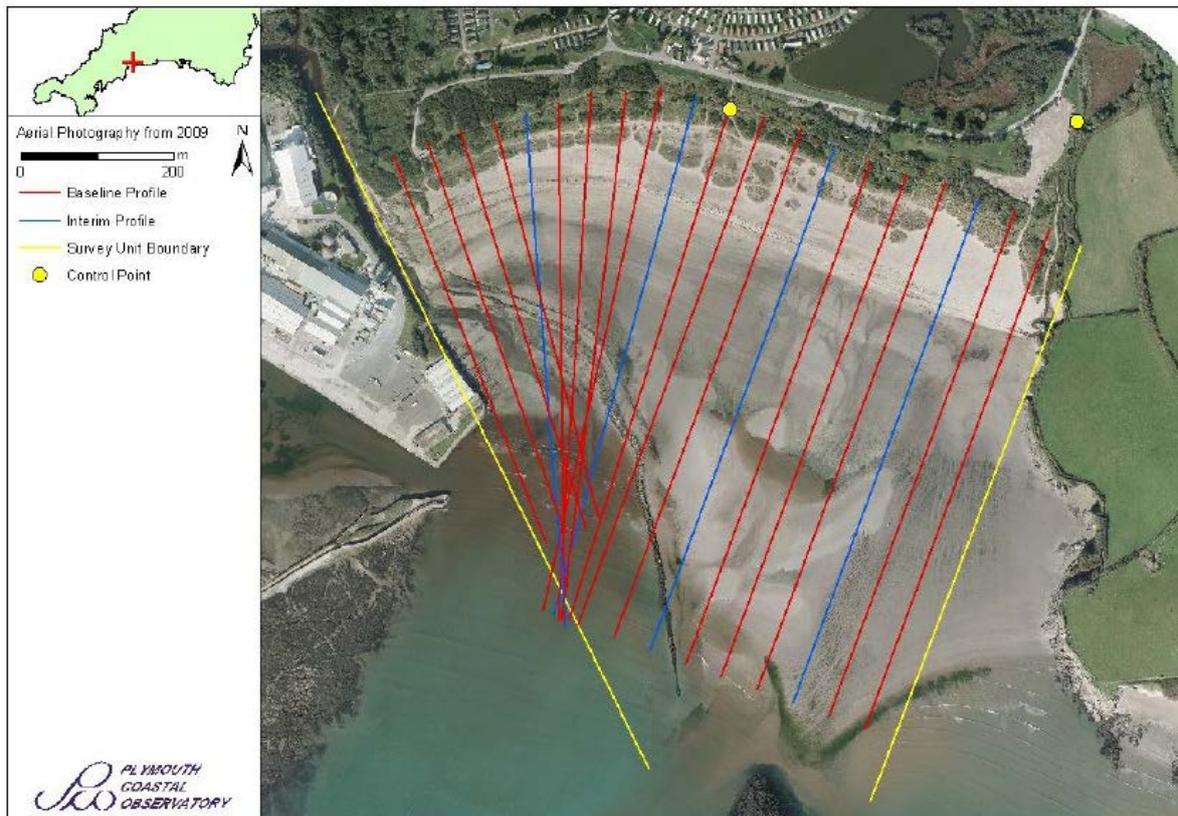
Figure 4.7 Location of beach profiles currently measured by the South West Regional Coastal Monitoring Programme at Par Sands (Source: Plymouth Coastal Observatory).

Figure 4.7 shows the location of the baseline and interim beach profiles measured at Par Sands.
